HO-922

Simpson Family Farm
11965 Simpson Road, Simpsonville
Howard County, Maryland

Maryland Inventory of Historic Properties Form

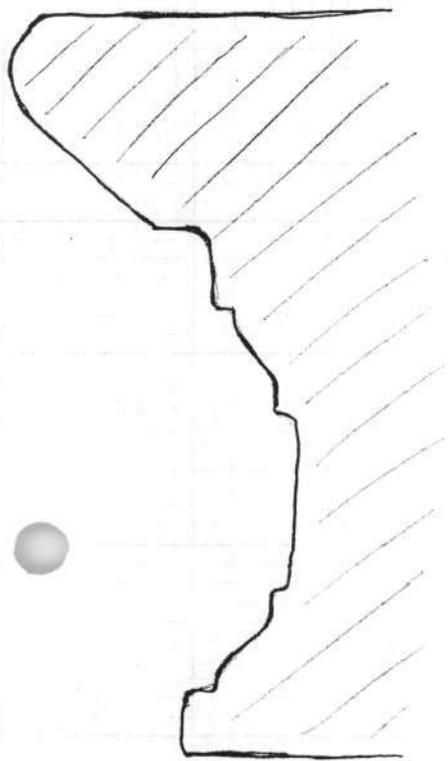
V/1 11965 Simpson Rd HO-922
Moulding Profiles

Transom
Bar

The northeast elevation has a center entrance with double doors that have three panels each. There is an eight-light transom and sidelights with four lights over one panel. All of the panels have sunken fields and ogee panel moulds. The transom bar has a Greek ovolo at the top, and is symmetrical below this with two Greek ogees flanking a center field. The doorway has a beaded-interior-edge mitered frame. There are two small six-over-six sash to the east of the doorway and two larger six-over-six sash to the north of the doorway. All of these windows have beaded-interior-edge mitered frames. There is a three-bay, one-story porch centered on this elevation. It has a hipped roof with asphalt shingles, four turned posts across the front and two half posts against the wall, jig-sawn brackets, and a tongue-and-grooved wood deck that was replaced by the current owners. The porch has bead-board on the soffit and a wood box cornice. The second story has five smaller six-over-six sash with beaded-interior-edge mitered frames. The house has a box cornice covered with aluminum.

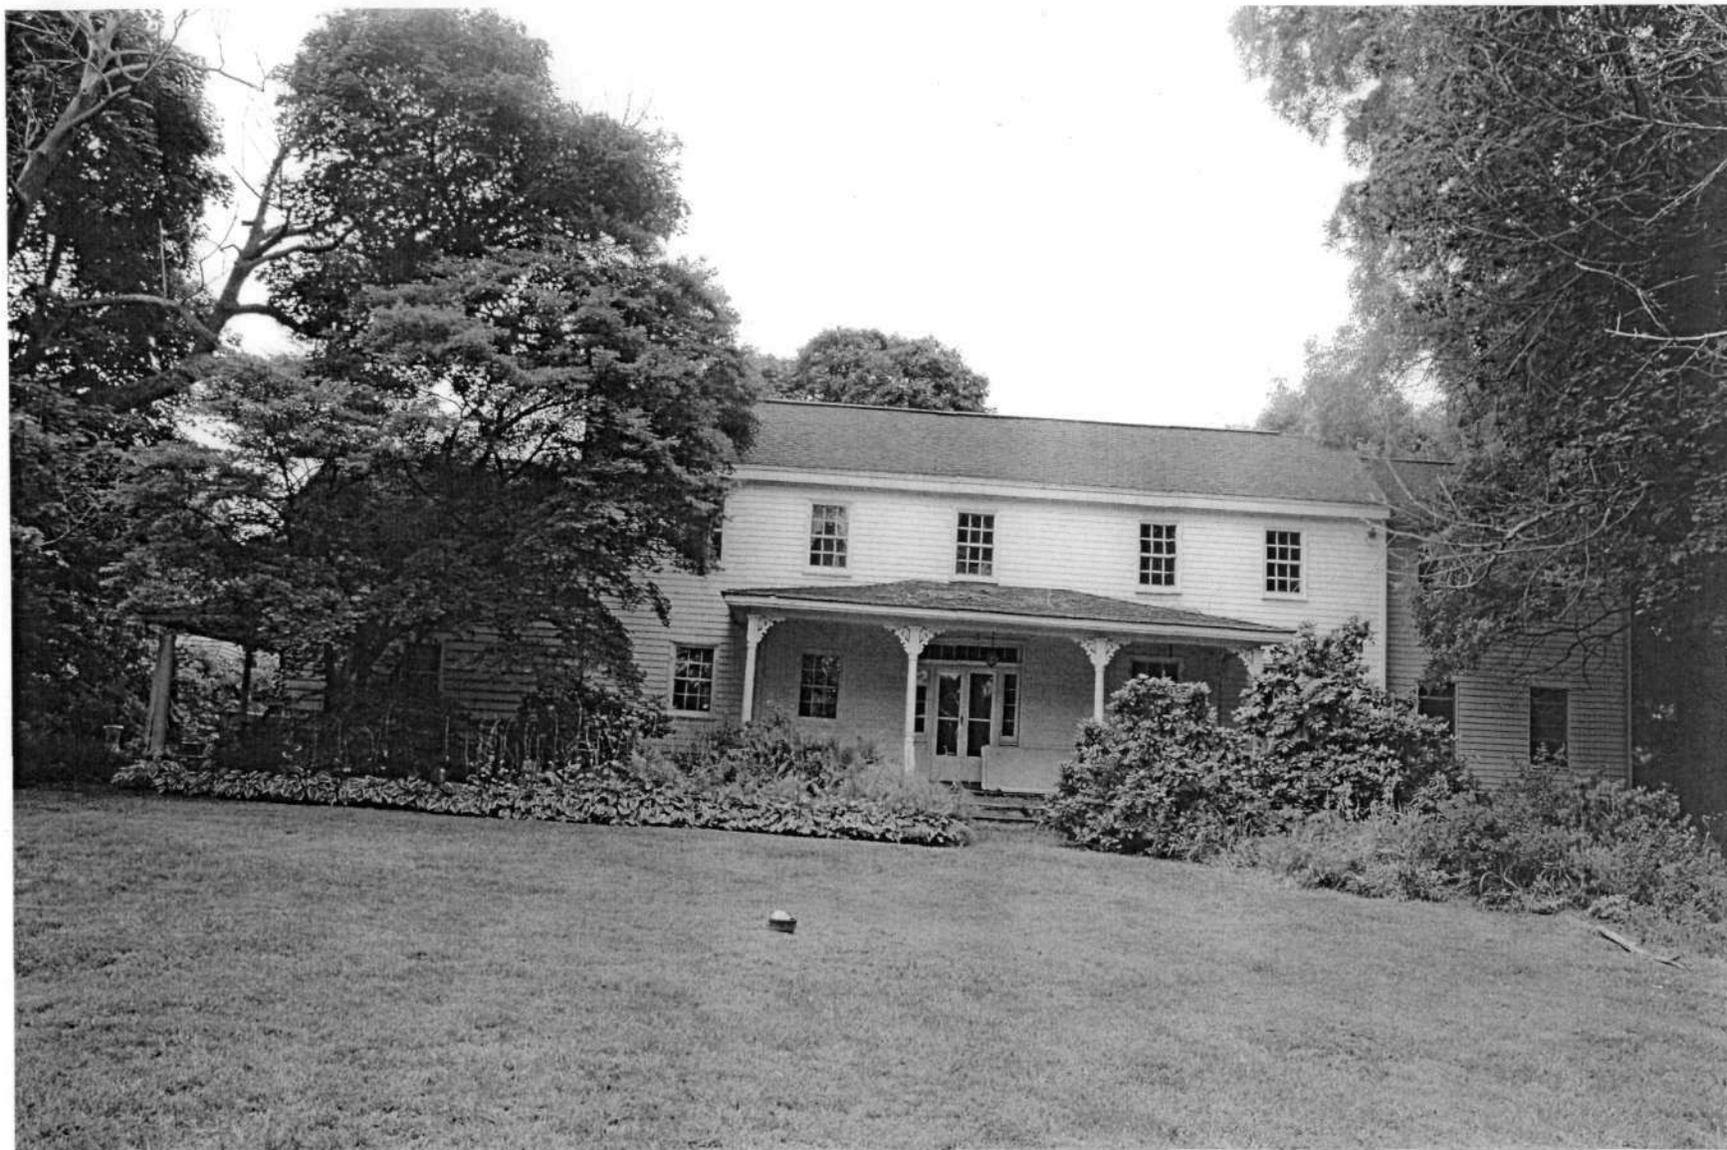
HO-922 Simpson Family Farm 11965 Simpson Road House, northeast elevation
Ken Short, August 2006 1/12

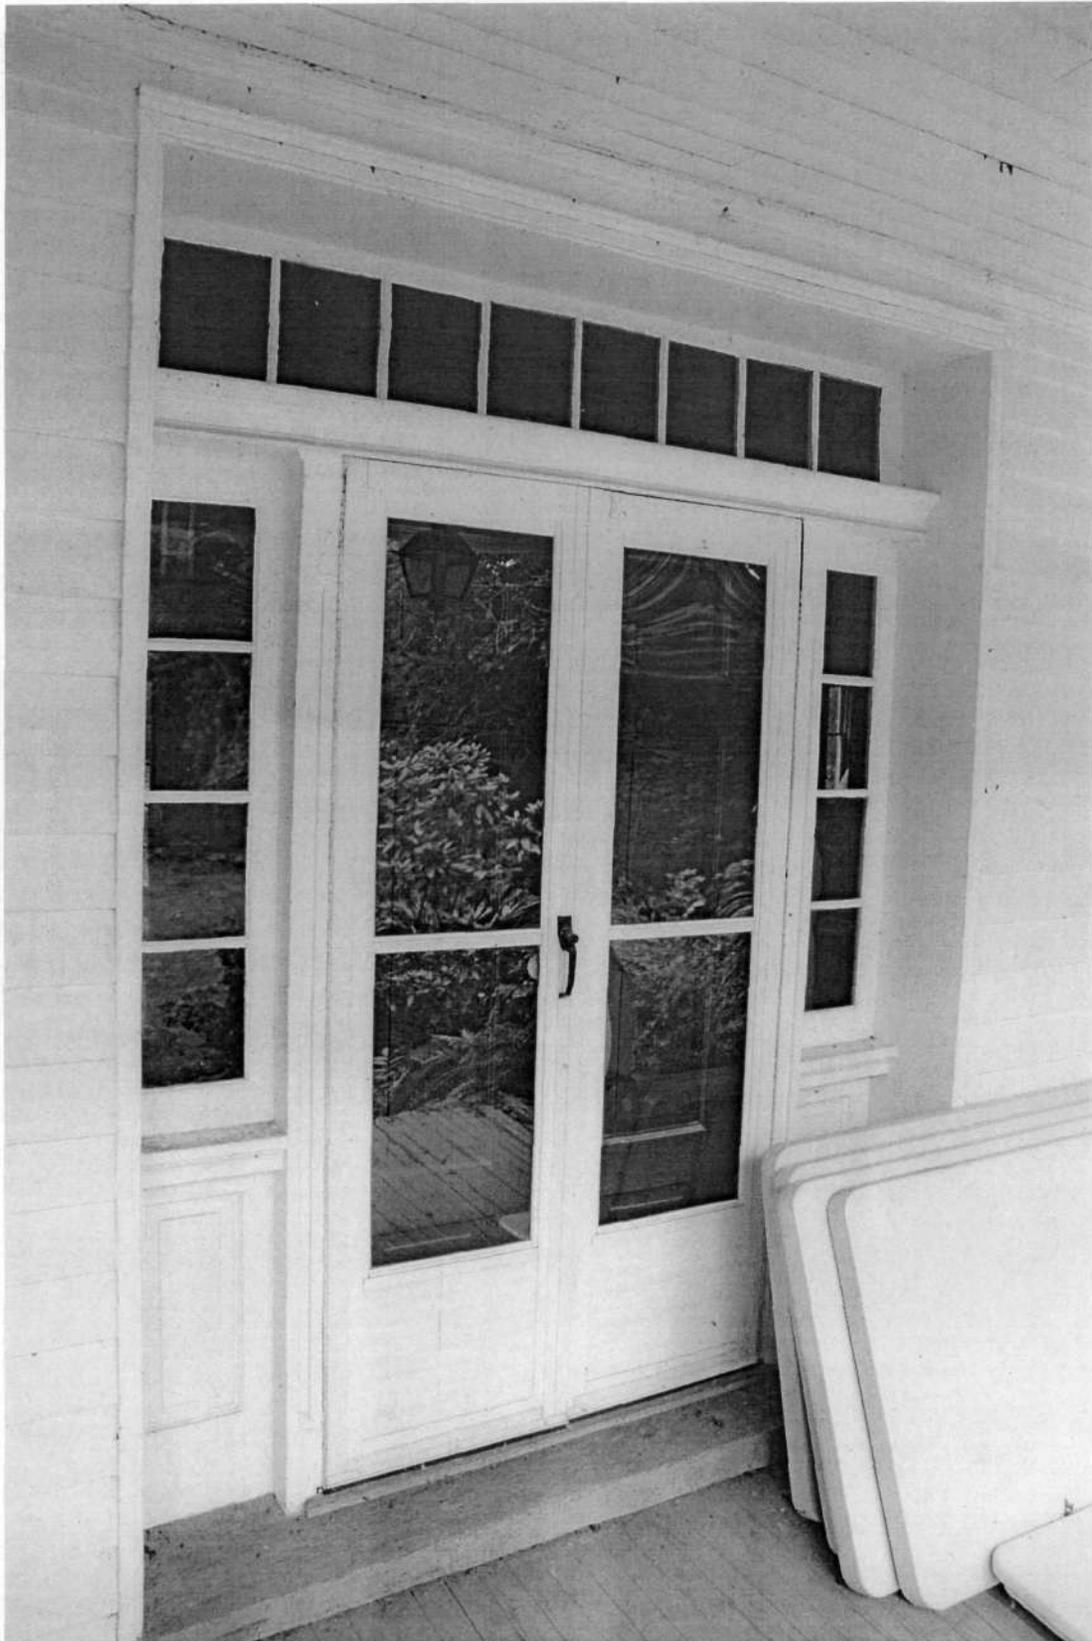
HO-922 Simpson Family Farm 11965 Simpson Road House, northeast elevation door
Ken Short, August 2006 2/12

the southwest and northwest. The center passage has new pine flooring added by the current owner. The front door is a double door with three sunken panels on each leaf, with ogee panel moulds. There is a plain cast-iron rim lock with a porcelain knob, and cast-iron hinges with five knuckles and what appear to be pins. The hinges are heavily painted, but appear to be plain. The side light panels match the door panels. The door, sidelights, and transom are all mortised and tenoned and pinned. There is plain architrave with a beaded interior edge and plain corner blocks. The southeast elevation has new double doors and new architrave and baseboard. The northwest elevation has new architrave, with an old original four-panel door that has a lying panel at the top and bottom. The panels have sunken fields and applied ogee panel moulds. The bottom panel appears to be hand-planed. The door is mortised and tenoned and pinned and has cast-iron butt hinges that have five knuckles and appear to be plain, though they are heavily painted. The door has a mortise lock with porcelain knobs, and this appears to be original, as there is no evidence of another lock. Most of the architrave had been removed when the current owners acquired the property. The northwest wall is exposed log with whitewash and plaster burns that indicate diagonal lath was added later. There is a straight run of stairs on the northwest wall that ascends to the southwest landing, and then turns to the northeast. The stairway has an open stringer that is plain, with only a bead at the bottom. There is a three-quarter-round handrail that appears to be walnut and a large newel post that also appears to be walnut and is urn-shaped at the base. The balusters are rectangular. There is a new door beneath the stairway, leading to a closet covered with drywall. The rear door beneath the stair landing is missing, and the jambs here have new mouldings added to them.

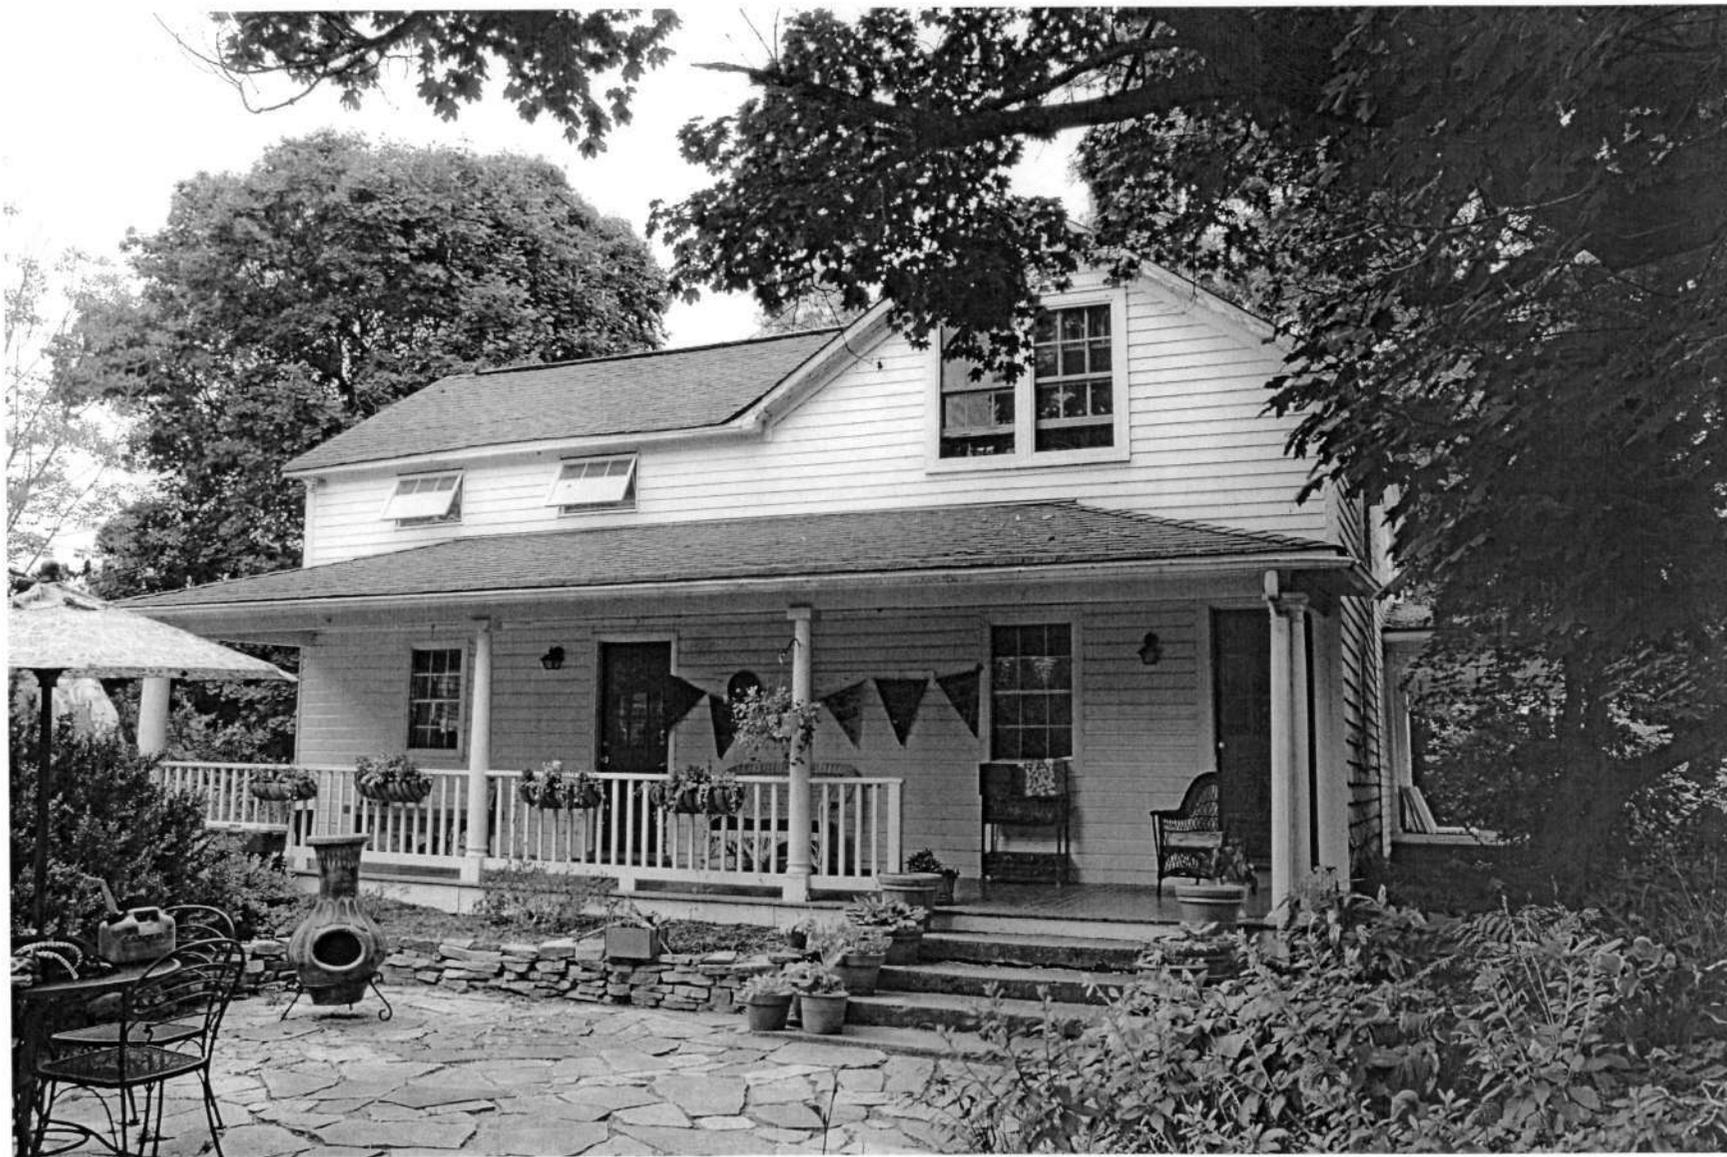
HO-922 Simpson Family Farm 11965 Simpson Road House, southeast elevation
Ken Short, August 2006 4/12

The northeast elevation of the southeast addition has a rubble stone foundation, weatherboards that have a half lap on the top board and are face-nailed with cut nails, and a wood box cornice with returns. The first story has a six-over-six sash with a modern frame, and the second story has a small six-over-six sash, also with a modern frame. The southeast elevation of the southwest and southeast additions, from south to east on the first story, has a six-over-six sash with a plain mitered frame; a new door with nine lights over a cross buck; a six-over-six sash with a modern frame; and a new door near the east corner that is a cross buck. There is a one-story, four-bay porch across this elevation. It has a tongue and groove wood deck and beaded-edge-and-center board soffit. There are Doric columns at the corners and two round posts in the center. The porch has a wood box cornice and a hip roof with asphalt shingles. The second story has two six-light casements, and paired six-over-six sash in the gable end of the southeast addition.

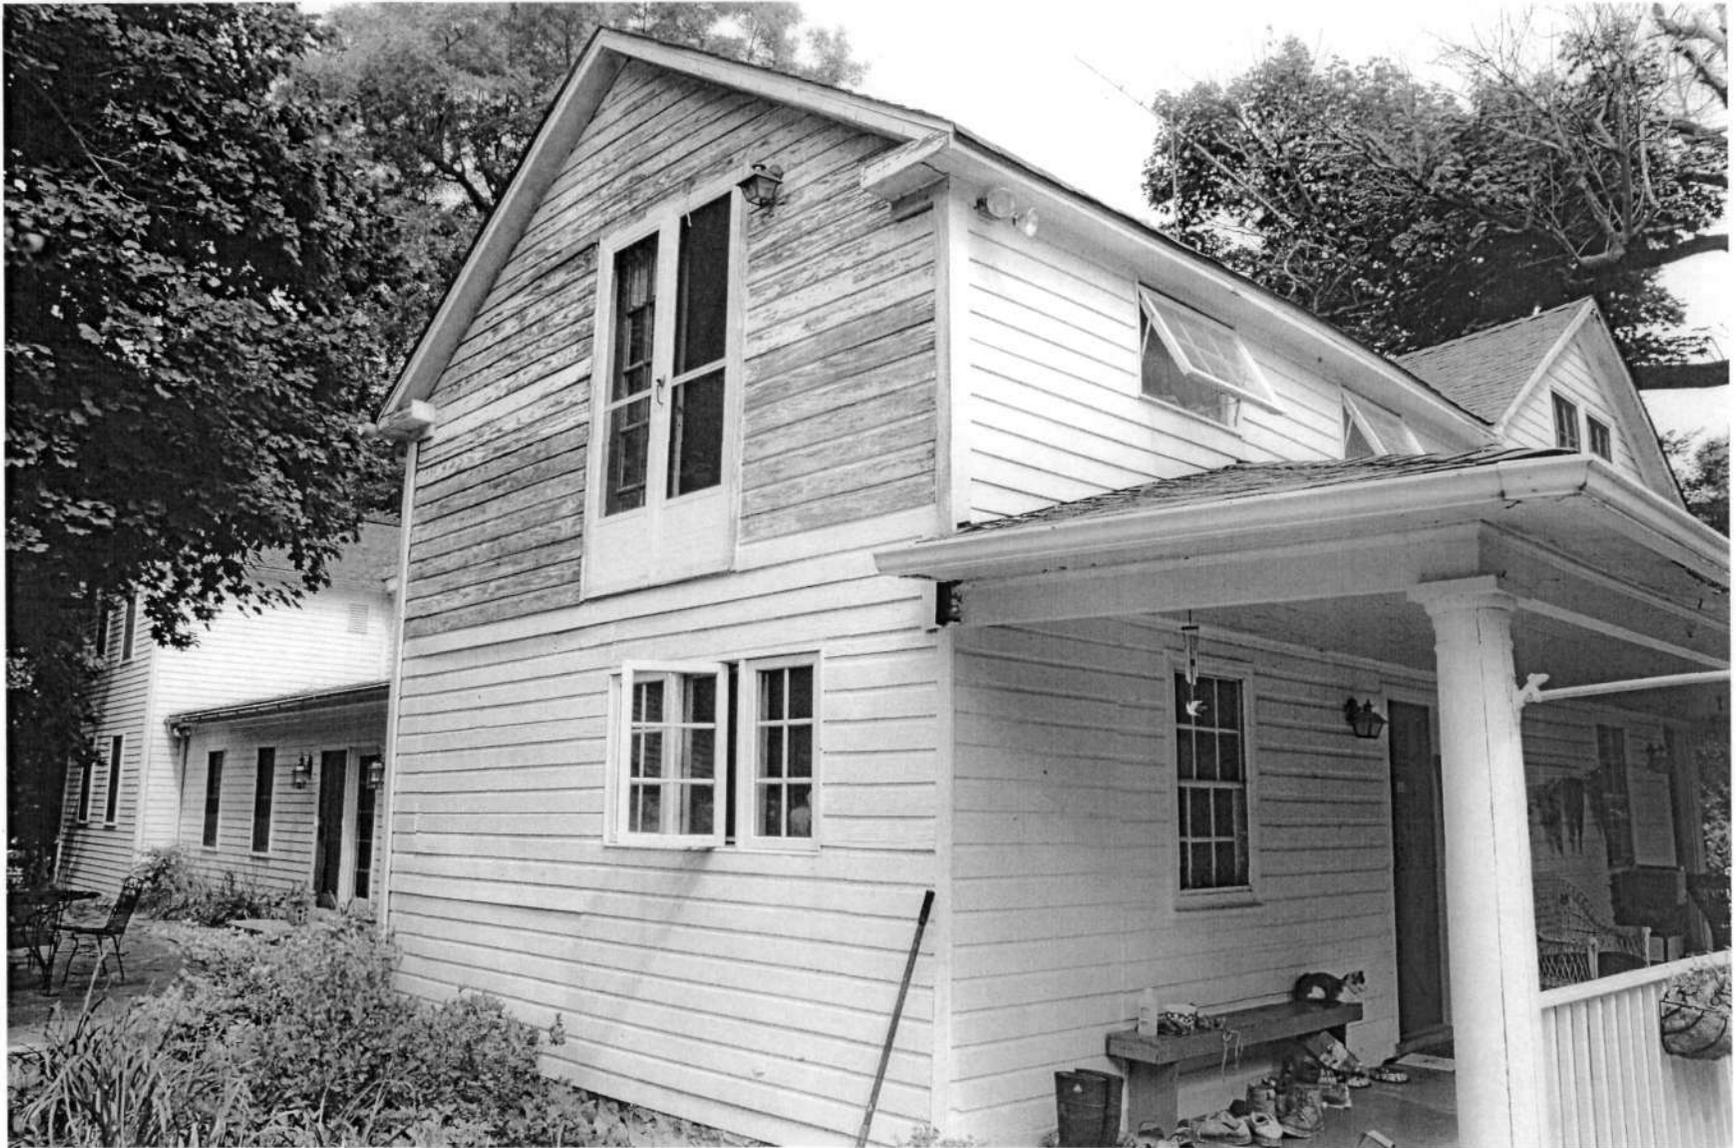
HO-922 Simpson Family Farm 11965 Simpson Road House, southwest & southeast elevations
Ken Short, August 2006 5/12

The southwest elevation of the southwest addition has German siding and a wood box cornice with returns. The first story has three new six-light casements, and the second story has French doors. The first story of the southwest elevation of the main block is a new addition with a shed roof and weatherboards. The second story has no opening in the center bay. There are four six-over-six sash with beaded-interior-edge mitered frames and shutter hinges. There is a wood box cornice. The northwest elevation is covered by the new addition.

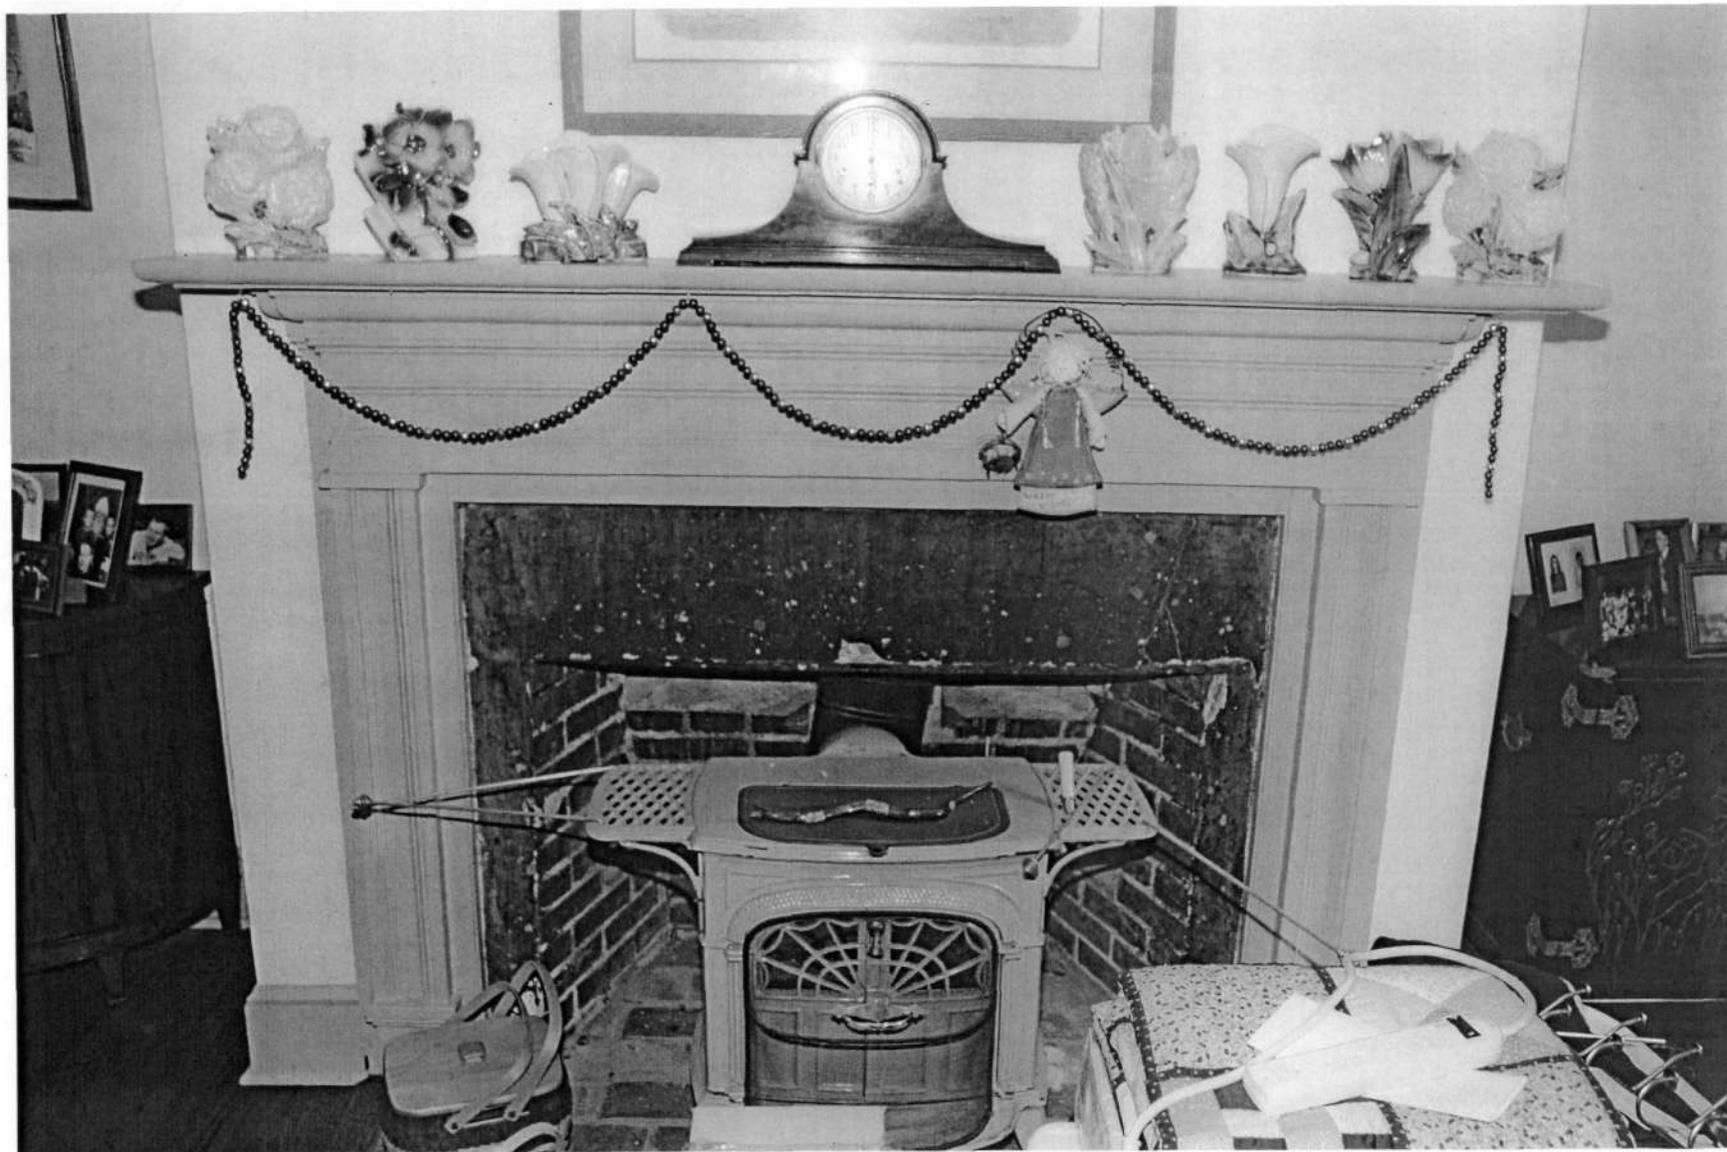
HO-922 Simpson Family Farm 11965 Simpson Road House, northwest room mantel
Ken Short, August 2006 7/12

The northwest room is a mortised and tenoned and pegged, heavy-timber frame according to the owners. The northwest room has new pine flooring added by the current owners, and new architrave. The southeast wall is now exposed log with whitewash on the chinking only, and has plaster burns that indicate diagonal lath. The window sash have 10-inch by 12-inch lights, ovolo muntins, and are mortised and tenoned and pinned at the corners and the muntins pinned on the top and bottom rails, but not on the meeting rails. The meeting rails are plain, and there are no parting beads. The fireplace is centered on the northwest elevation, and it has a brick hearth and splayed brick jambs. There is an iron lintel above the opening, and it was parged over when the surround was parged. The wood mantel has pilaster strips consisting of symmetrical architrave that has a quirked ogee-and-bevel on each side. The frieze is the same, with the architrave running lengthwise. The bed mould has a quirked ogee-and-bevel below a large ovolo moulding. The mantel shelf has an ovolo on the edge. On the southwest wall, two windows were converted to doors when the addition was put on the southwest by the owners. The northwest addition is about five years old.

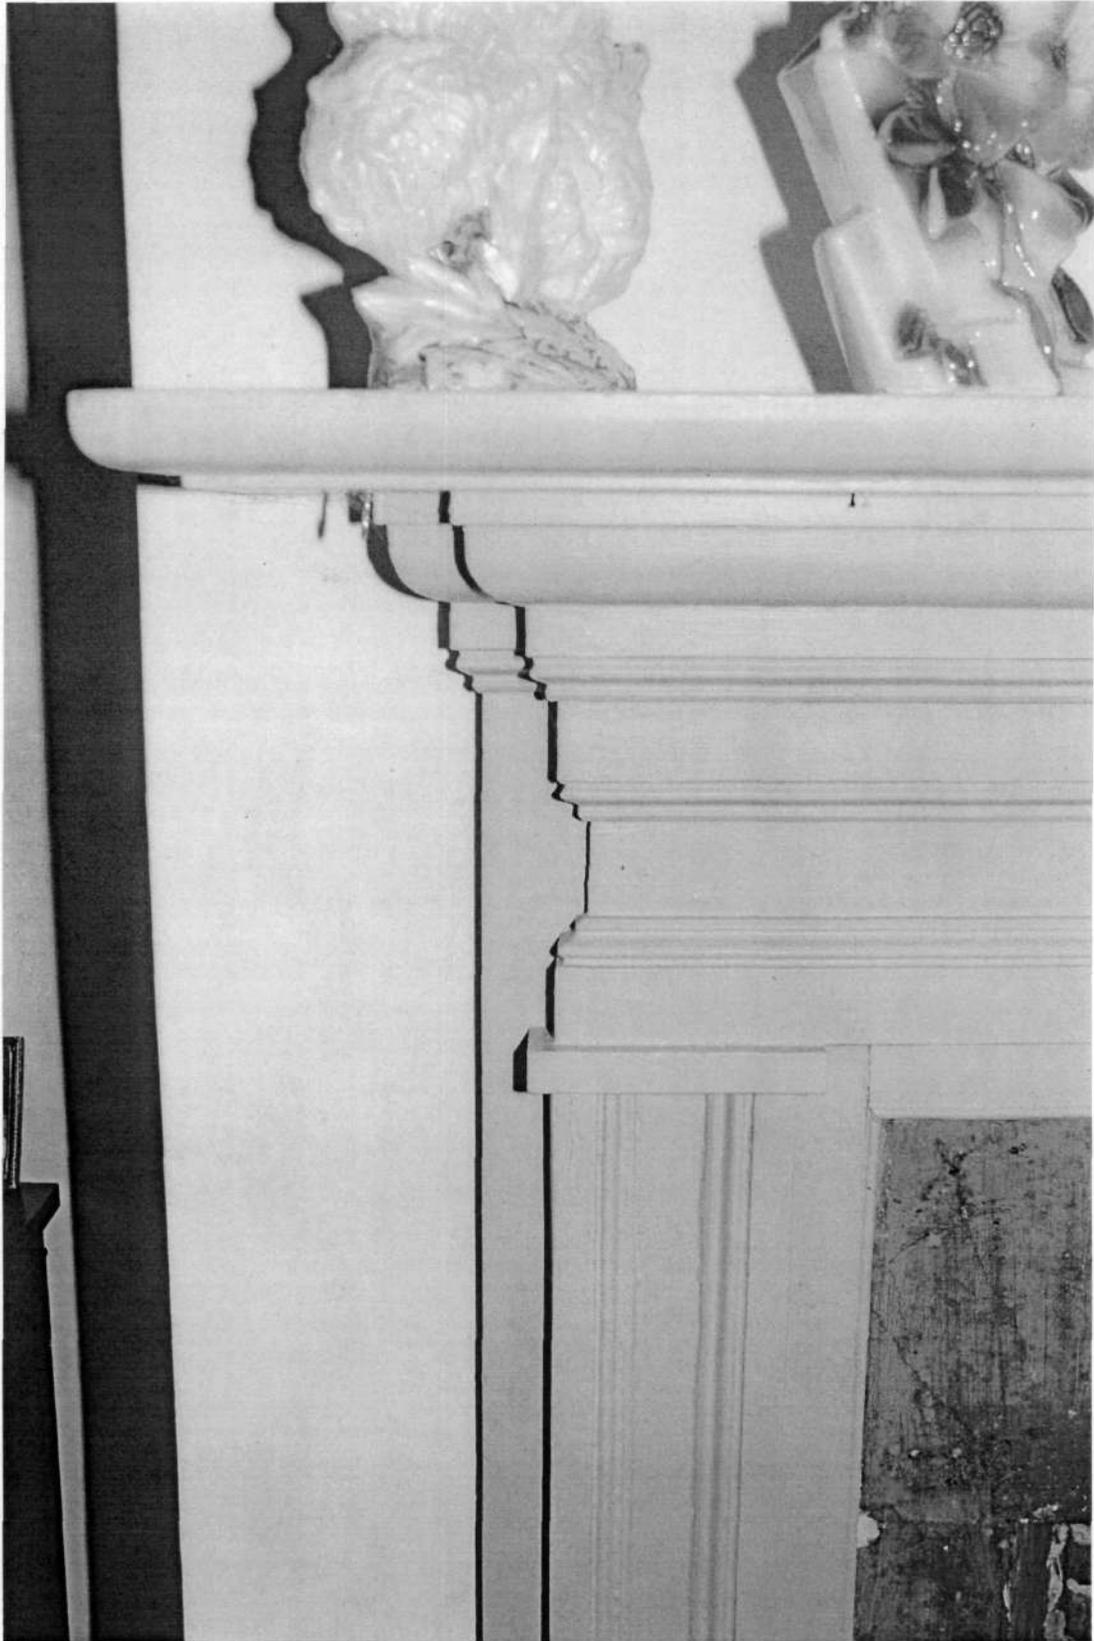
HO-922 Simpson Family Farm 11965 Simpson Road House, northwest room mantel detail
Ken Short, August 2006 8/12

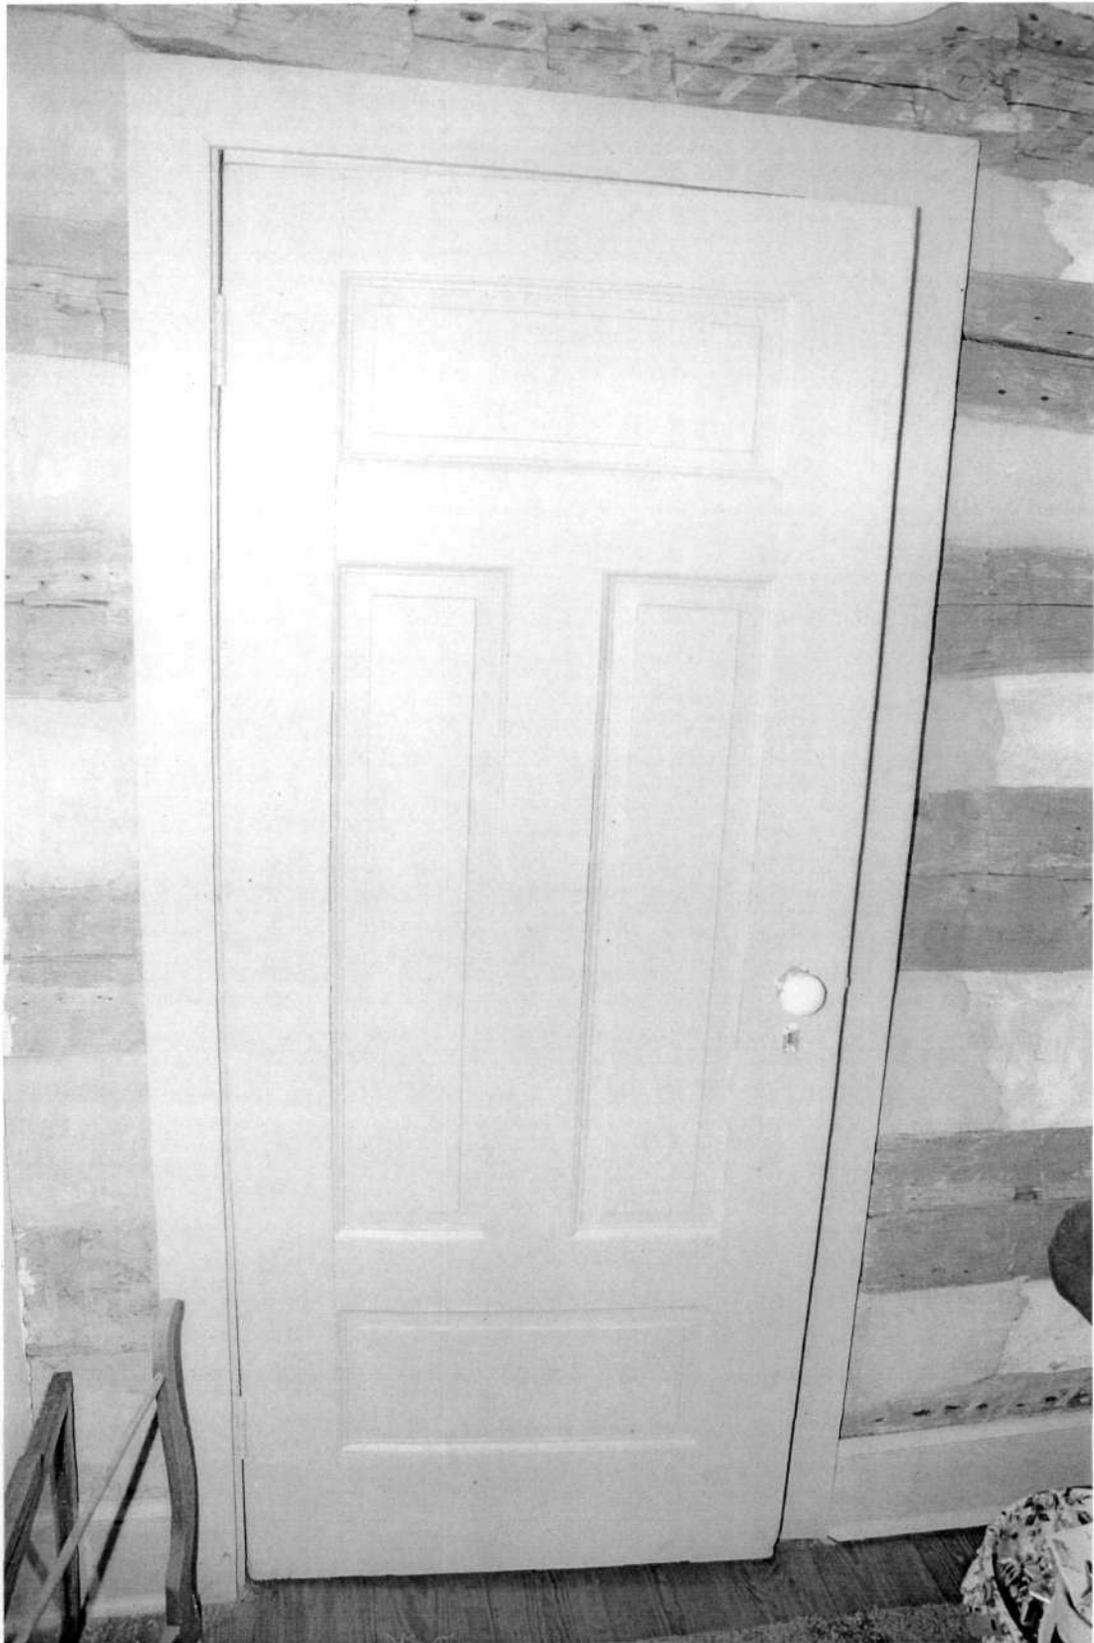
HO-922 Simpson Family Farm 11965 Simpson Road House, northwest room door
Ken Short, August 2006 9/12

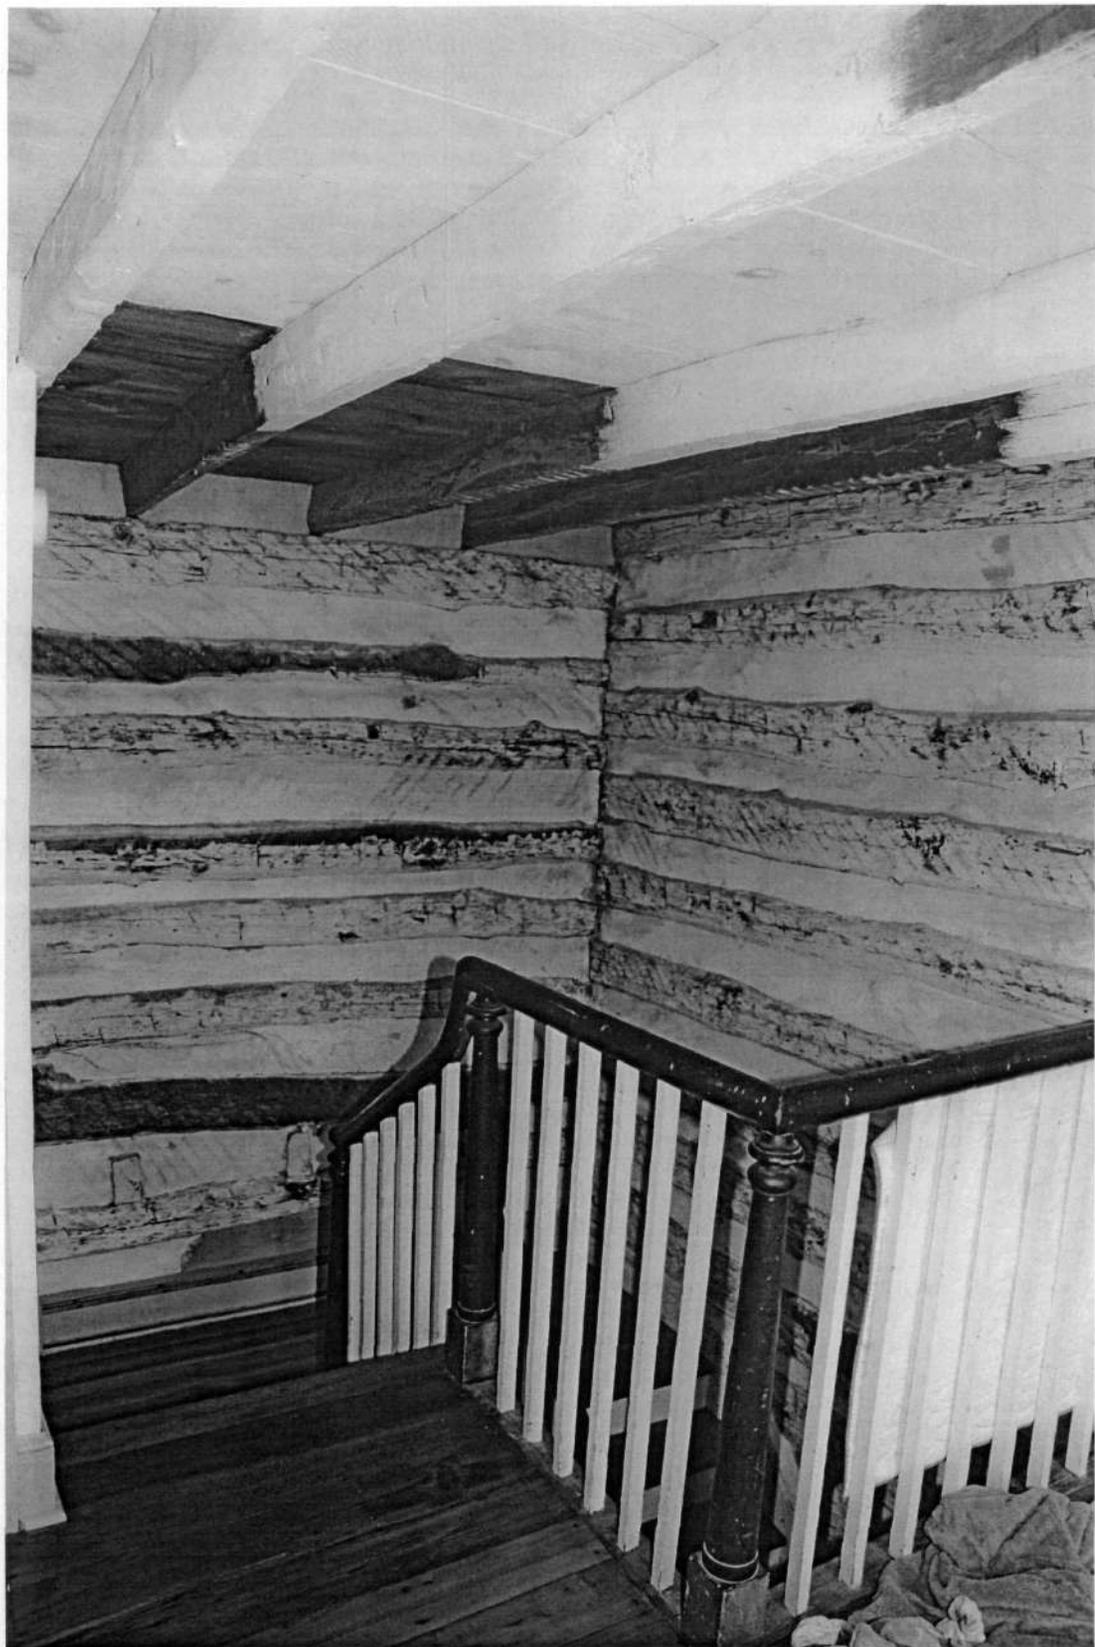
HO-922 Simpson Family Farm 11965 Simpson Road House, 2nd sty stair hall, vw west
Ken Short, August 2006 11/12

The second story has a similar plan to the first story. The passage has 4 1/2- to 6-inch-wide pine flooring. The baseboard is all new. There are exposed logs on the northeast, northwest and southwest walls. The logs are whitewashed, and then had vertical lath on the northeast and diagonal lath on the other two walls. The north corner appears to have V-notch corners. The attic floor joists are exposed and are hewn. They run northeast-southwest, are 2-1/2 to 3-1/3 inches by 6 inches, and are spaced 19- to 28 1/2-inches on centers. The joists are set between the logs of the front and rear walls, and neither the logs nor the joists are notched. The attic flooring is circular-sawn. The stairway ends at the second story and has the same details as the first story. There is no evidence that it could have gone up to the attic, as no joists are cut. The northeast window logs have a diagonal cut in the log that is at the top of the window. This feature could indicate that the window opening was cut through after the logs were laid up. A wide saw blade would have to cut at an angle to begin with, until there was enough space for the wide blade to sit upright between the logs. The northeast window has top and bottom sash that are made differently from the other second-story sash. The bottom sash muntins are not cut through on the meeting rail. Both have 8-inch by 10-inch lights. The northwest door has new trim and new hinges, but the door has four panels with sunken fields and ogee panel moulds. The door is mortised and tenoned and pinned, and the lock rail is hand-planed. There is a cast-iron rim lock with a mineral knob. The southeast wall has been pushed back to get two doors in this wall and divide the southeast chamber into two rooms. The door to the east is old, and has four panels with lying panels at the top and bottom. The panels have sunken fields and no panel moulds, and the door is mortised and tenoned and pinned. There are new hinges and a cast-iron rim lock with a metal knob.

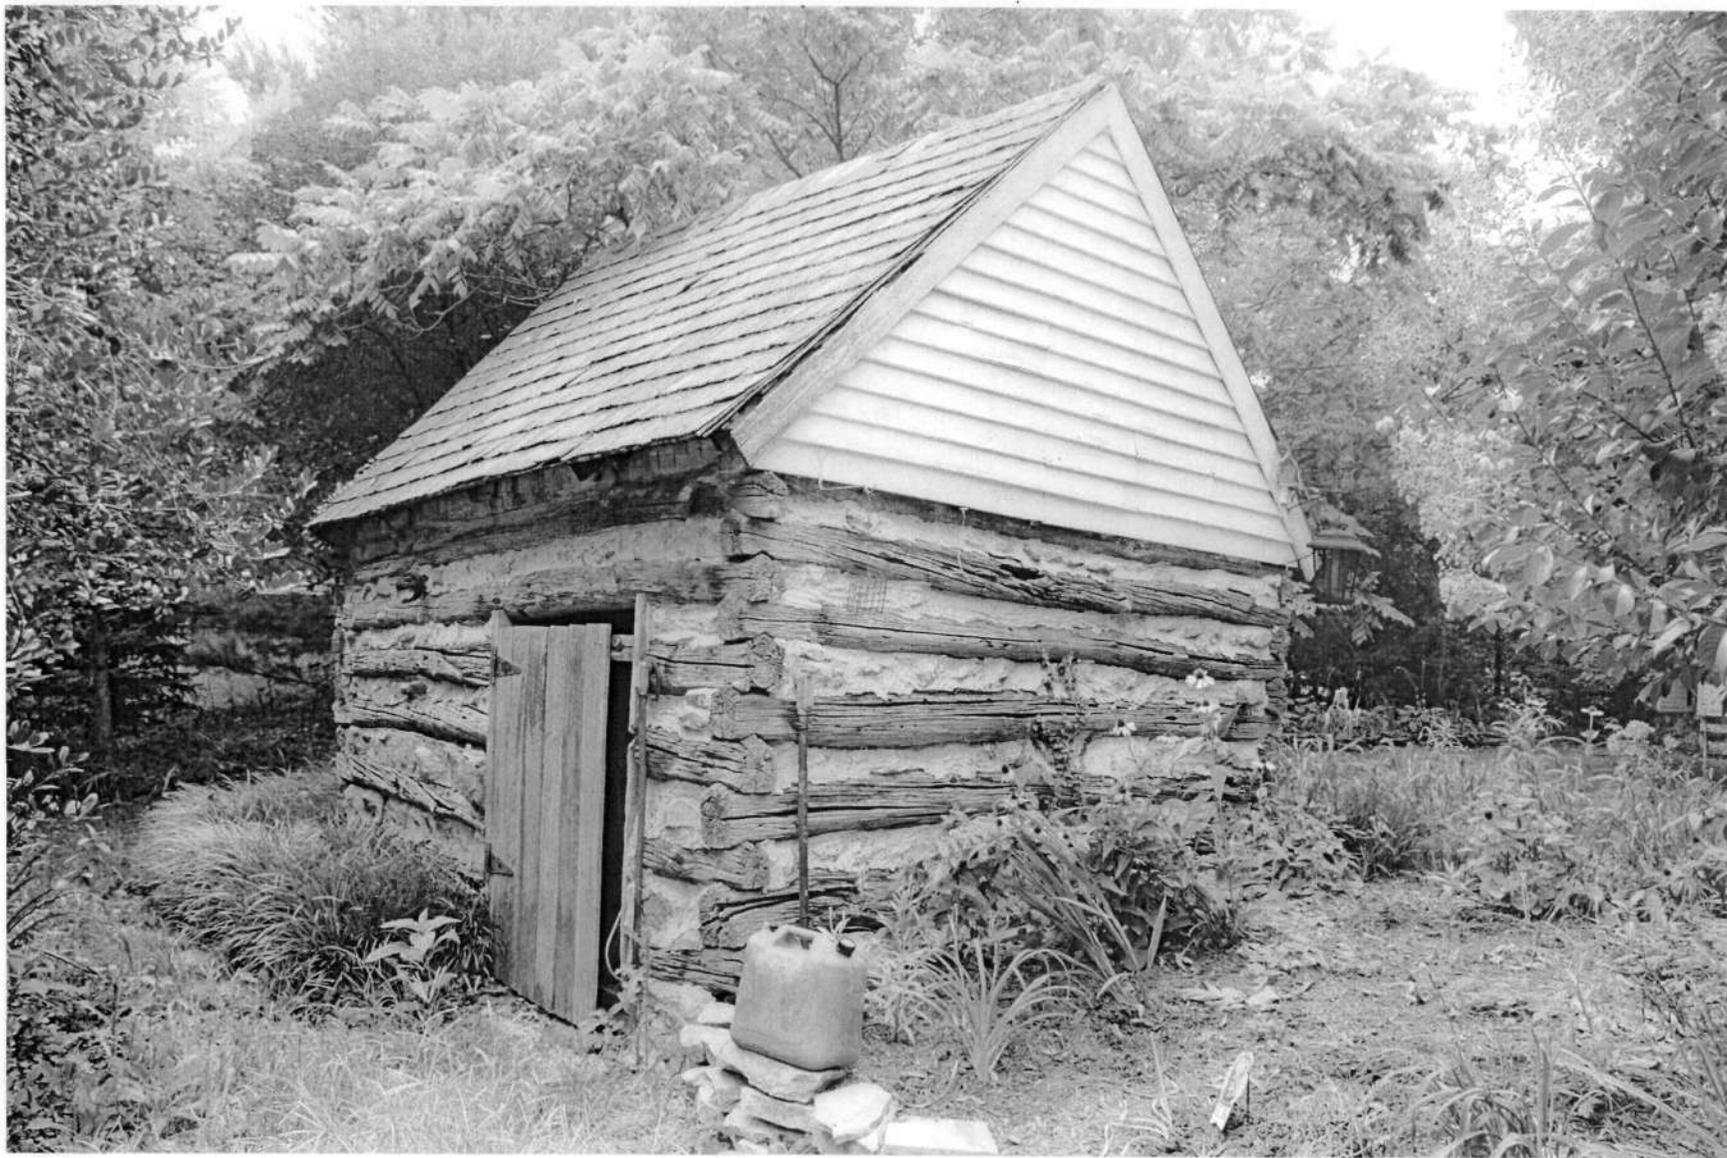
HO-922 Simpson Family Farm 11965 Simpson Road Smokehouse, northeast & northwest elevations
Ken Short, August 2006 12/12

There is a smokehouse located about 20 feet south of the house. It is a one-story, one-bay by one-bay exposed log structure with V-notch corners, and some of the logs are very rotted. It has a gable roof with wood shingles and a northwest-southeast ridge. The chinking has been redone with concrete. The gable ends have weatherboards. The northeast elevation has a new weatherboard door in an original opening that has been widened with a new jamb board on the east side. The north jamb board is pegged to the log ends. The rafter ends are exposed. There are no other openings in the building. The interior has two log joists running northeast-southwest. The rafters are approximately 3 inches by 4 inches and appear to be mitered at the ridge. They appear to be sawn and support shingle lath.
